Technical Bulletin

Model 911SC, 928S	Group 00
Part Identifier N/A	Number 83-01

Subject: Location of VIN Label

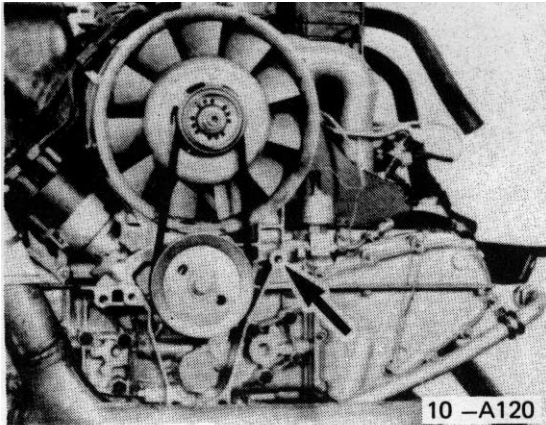
Fig. 1, Mounting bolt location

On some vehicles, oil may leak from the upper right mounting bolt for the rear engine carrier (Fig. 1, arrow)

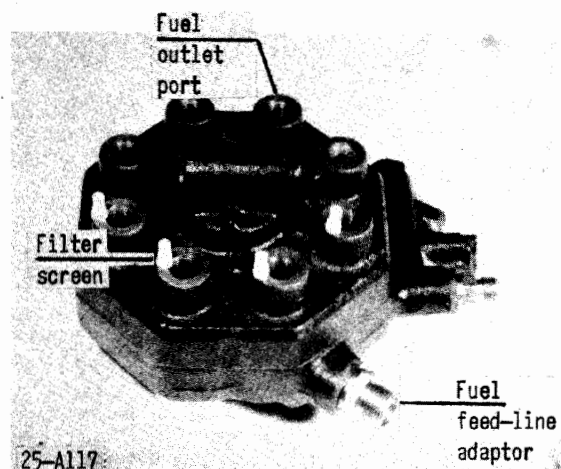
Engine misfiring may result from fuel restriction to one or more injectors

- check for loose fuel filter screens in fuel outlet ports of fuel distributor
- if loose, replace all 8 bolts (arrow) with new bolts, Part # 930 110 547 00

- clean filter screen in fuel feedline adaptor
- run engine and check performance

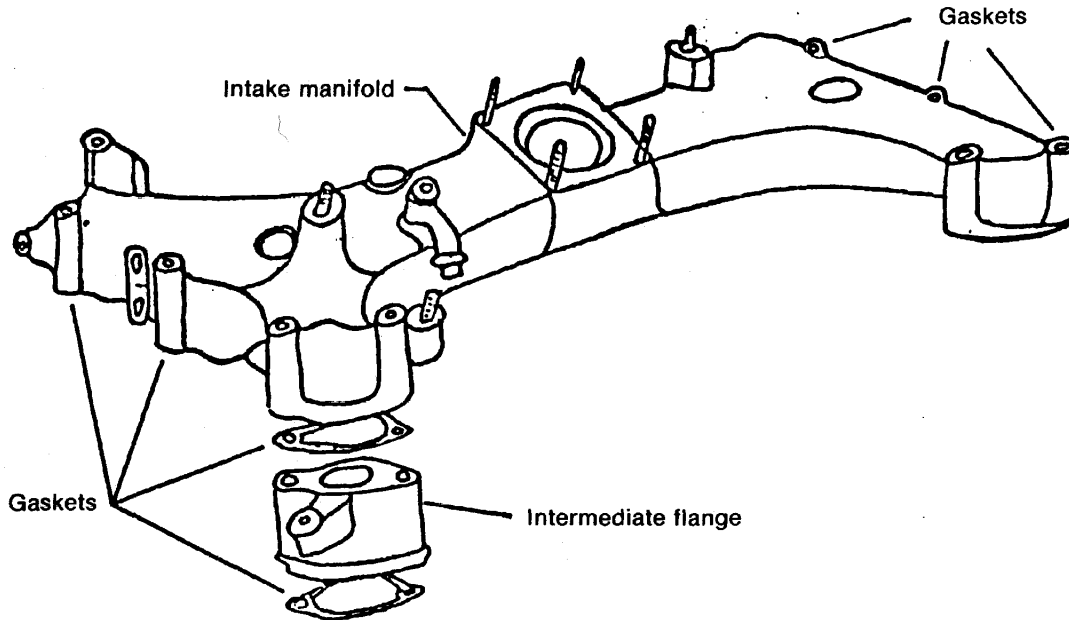
Engine surging at part throttle under load (similar to ignition misfiring) can be caused by a leaking intake manifold gasket.

— replace gasket or gaskets as required (see illustration)

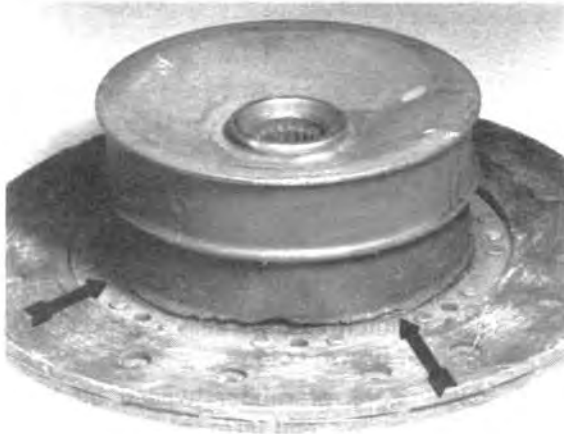
Figure 1

- Rubber hub broken loose from the metal disc plate.
- Corrosion on the metal disc plate (arrows) caused by overheating.
- Rubber adjacent to the metal disc is cracking, shiny, and sticky.

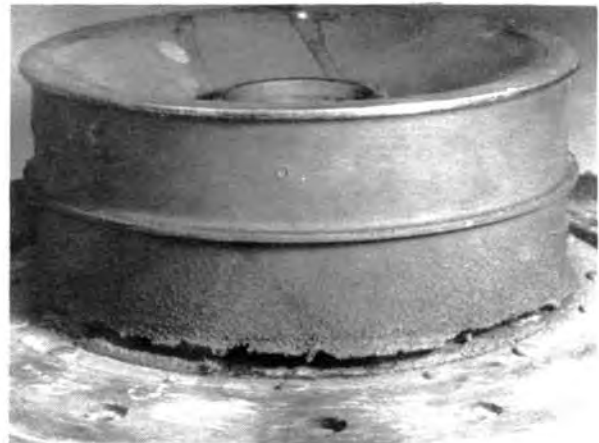
Figure 3

Cause: Abuse, unless mechanical failure of throwout bearing or bearing sleeve is evident.

- The rubber hub shows large cracks adjacent to the metal disc.
- The rubber surface is shiny and sticky in that area.

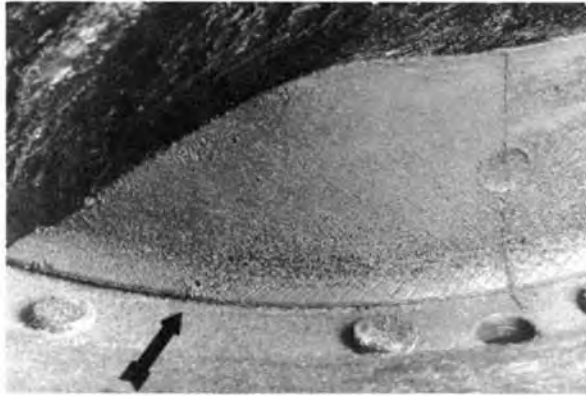
Figure 4

- The rubber hub shows small cracks adjacent to the metal disc (arrow).
- The rubber surface is shiny and sticky in that area.

Cause: Abuse, unless mechanical failure of throwout bearing or bearing sleeve is evident.

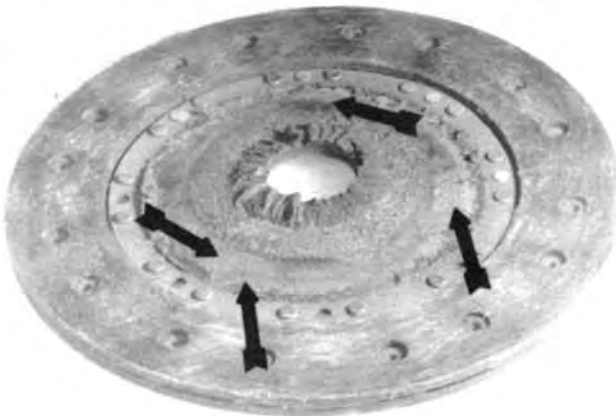
Figure 5

- Metal on clutch disc corroded to reddish-brown color (arrows) caused by excessive heat.
- No black, shiny adhesive visible on metal disc.
- Clear signs of rubber twisted off the clutch plate metal.

Cause: Abuse, unless mechanical failure of throwout bearing or bearing sleeve is evident.

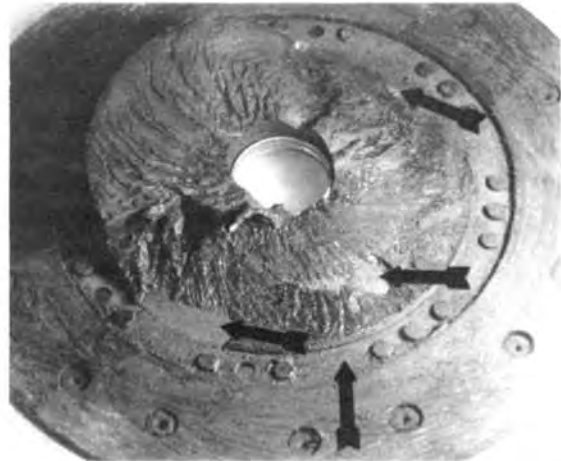
Figure 6

- Metal clutch disc partially corroded to reddish-brown color.
- Clear signs of rubber twisted off the clutch plate metal (arrows).

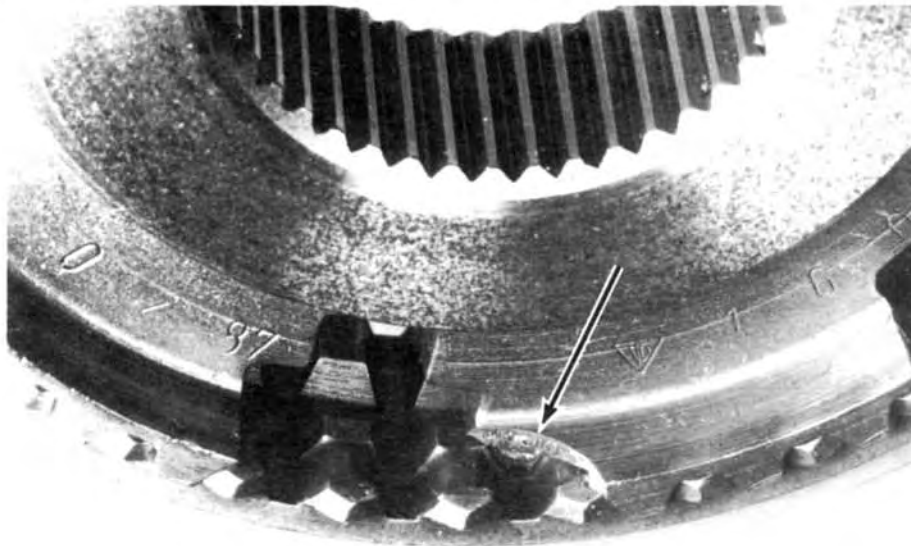
Broken stop for sliding sleeve

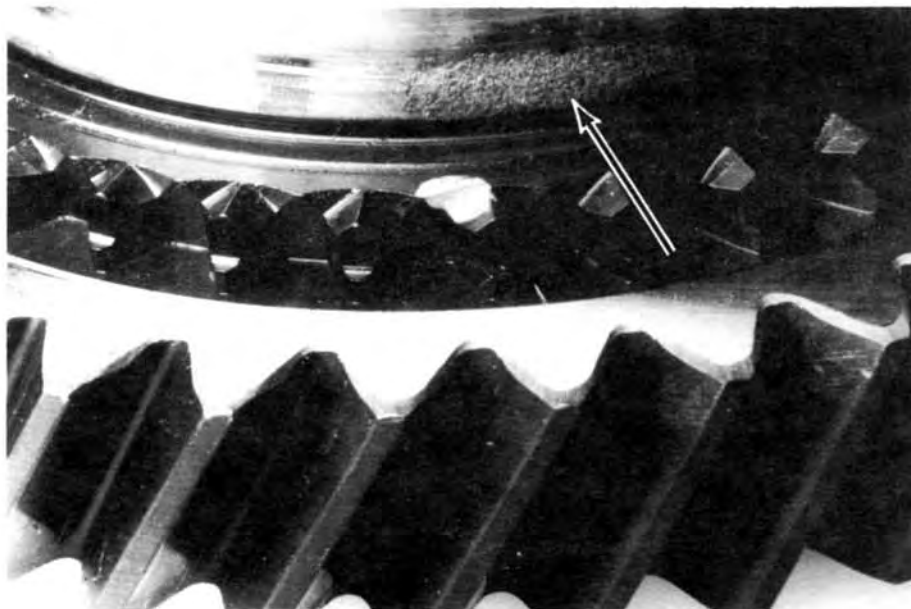
Metal transfer from synchronizing ring

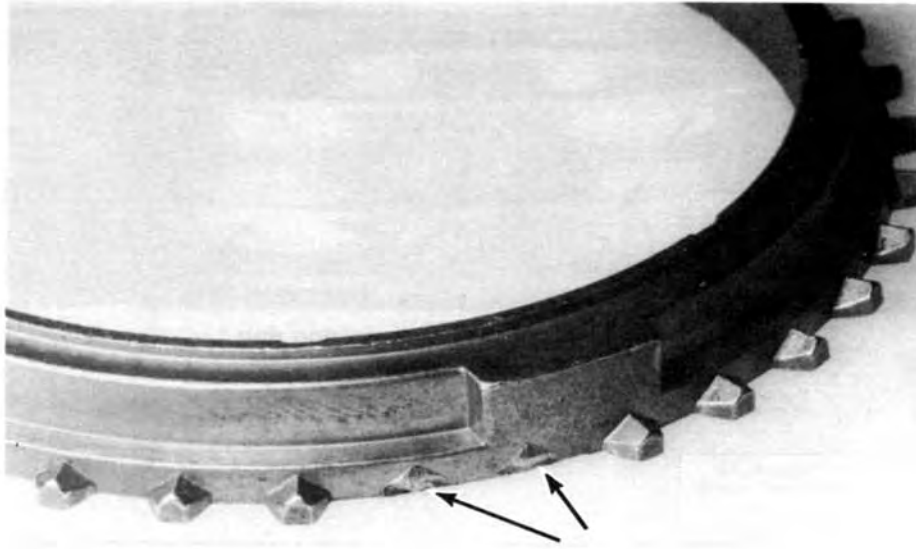
Broken teeth

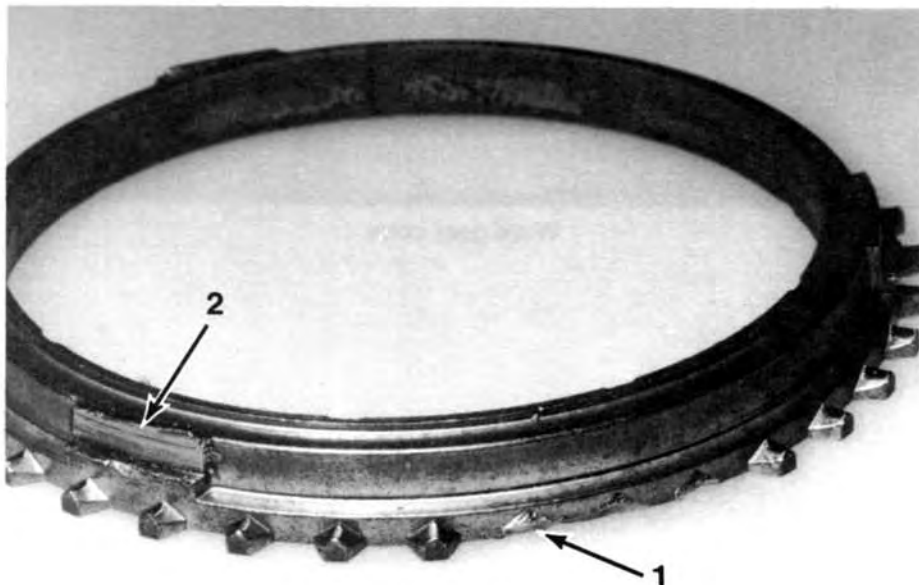
Broken teeth (1) and damaged stop (2)

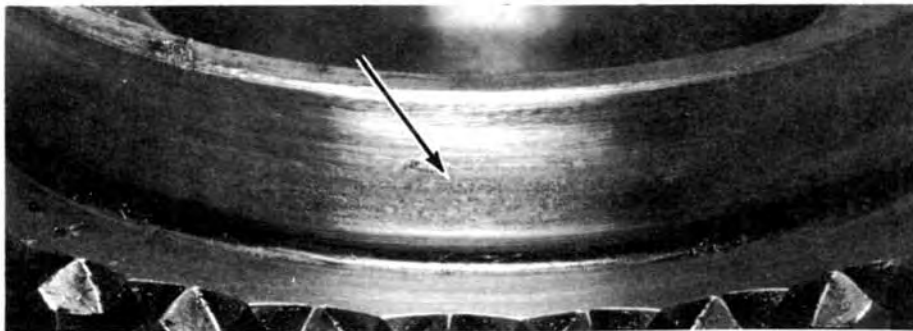
Worn gear cone

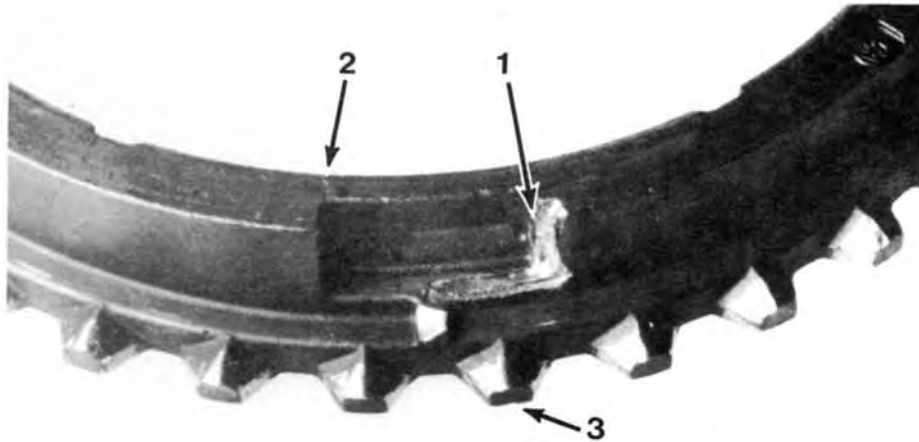
Damaged intercept stop (1) crack on intercept stop (2)
rounded teeth (3)

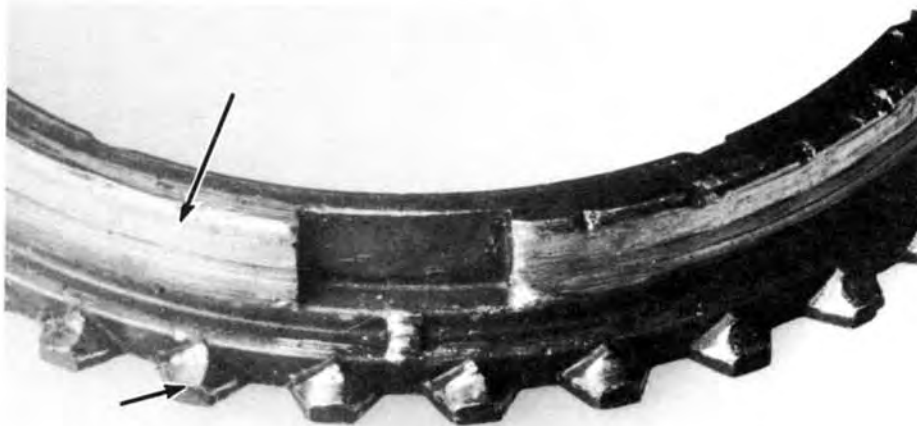
Worn synchronizing ring and damaged teeth
