Technical Bulletin

Model 911SC, 928S	Group 00
Part Identifier N/A	Number 83-01

Subject: Location of VIN Label

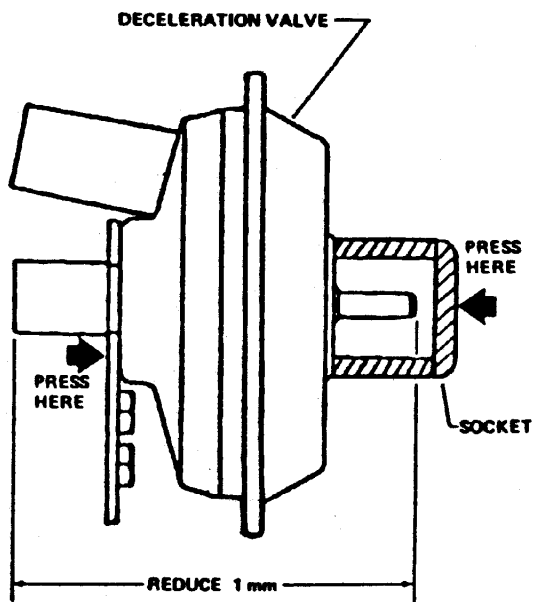
If above procedure does not stabilize idle speed:

- Remove deceleration valve
- Using a suitable socket, compress valve by 1mm as shown.
- Reinstall valve.

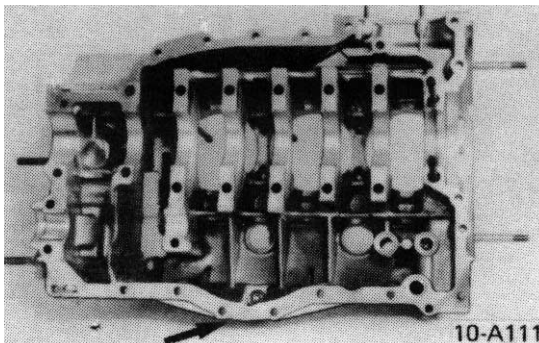
Fig. 1 Crankcase half

To increase crankcase strength, the removable oil filter screen and cover plate with oil drain plug have been eliminated. (Fig. 1, arrow)

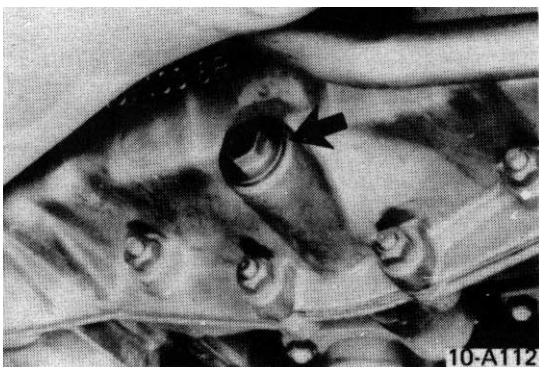
Fig. 2

Oil drain plug is now located on left side of crankcase. (Fig. 2, arrow)

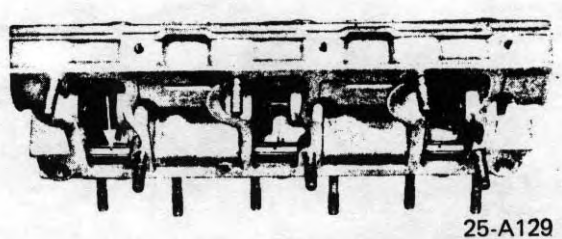
25-A129

During major engine repairs, check oil splash tubes (arrow) for possible clogging. Clogged tubes can cause premature wear of cam lobes and rocker arms

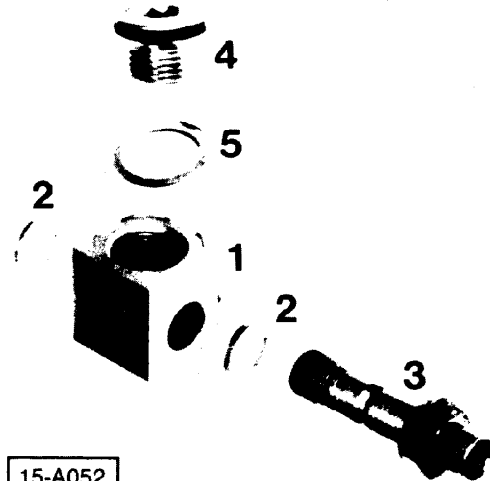
On 1968 through 1973 Models, the right side oil supply hose will not be long enough as provided. To correct, install adaptor block where inboard end of hose connects to case (arrow).

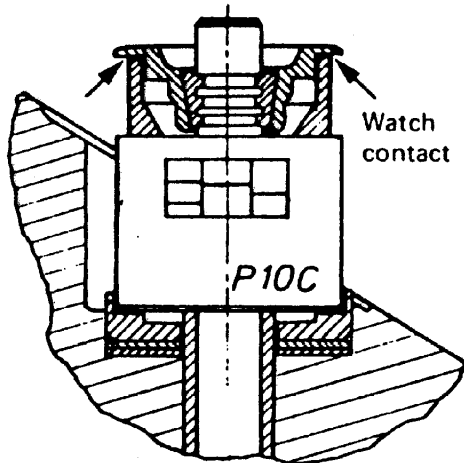
During 1980 model year, valve spring seats, Part No. 901 105 421 03, were introduced. These new seats have modified dimensions at the outer spring seating surface.

When making repairs, it may be found that, due to combination of unfavorable tolerances, the spring seat does not properly contact special tool "P 10c Setting Gauge" when measuring assembled valve spring length.

Existing P 10c tools should be modified as follows:

— increase inside diameter of the inner tube from 24.3 mm to 24.8 mm by turning or grinding

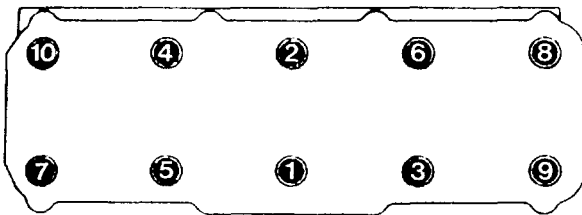
This technical information replaces all previous instructions concerning the tightening of cylinder heads on 924 vehicles produced from 1977 to 1982 (except Turbo).

Step 1: 65 Nm (48 ft. lbs.)

Step 2: 180 degrees (½ turn)

Sequencing as shown must be kept for each step. Threads and bearing surfaces of bolts must be lightly lubricated with oil prior to installation. Washers must not turn while tightening. Create a reference mark if necessary. Replace head bolts at each repair. When using torque angle method, cylinder head retorque is not necessary.

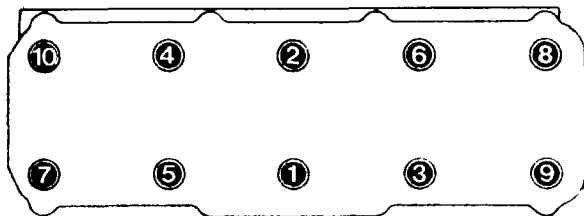
This technical information replaces all previous instructions concerning the tightening of cylinder heads on 924 Turbo vehicles produced from 1980 to 1982. The following parts are valid for repairs.

Tightening is done in 5 steps but not to the torque angle method:

- Step 1: Tighten head bolts to 40 Nm (29 ft. lbs.) following sequence
- Step 2: Tighten head bolts to 80 Nm (59 ft. lbs.) following sequence
- Step 3: Tighten head bolts to 110 Nm (81 ft. lbs.) following sequence
- Step 4: After at least 60 minutes, retighten cylinder head bolts by first loosening No. 1 bolt (see sequence) by ½ turn and then retightening to 110 Nm (81 ft. lbs.) Apply procedure to remaining bolts in sequence.

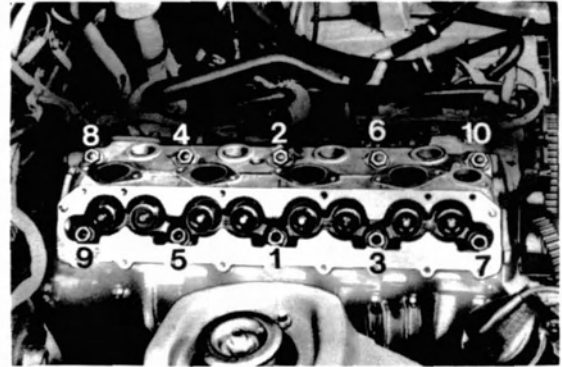
The torque angle tightening method is now valid for all engines of types 924S, 944, 944S and 944 Turbo including all earlier engines from start of 944 production. When making repairs, the following parts must be used:

- Step 1: 20 Nm (15 ft. lbs.)
- Step 2: 90 degrees (¼ turn)
- Step 3: 90 degrees (¼ turn)

Sequencing as shown must be kept for each step. Threads and bearing surfaces of nuts must be lightly lubricated with oil prior to installation. Washers must not turn while tightening. Create a reference mark if necessary.

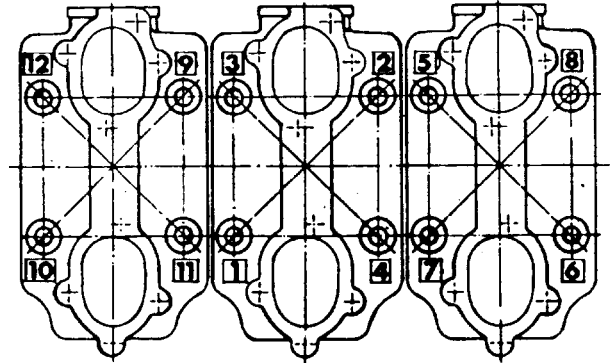
**Cylinder Head
Tightening Sequence**

This technical information replaces all previous instructions in repair publications concerning the tightening of cylinder heads on the 911 Carrera.

Step 1: Torque to 10 Nm (7 ft. lbs.) in correct order.

Step 2: Final torque to 32 Nm (23 ft. lbs.) in correct order (see sketch).

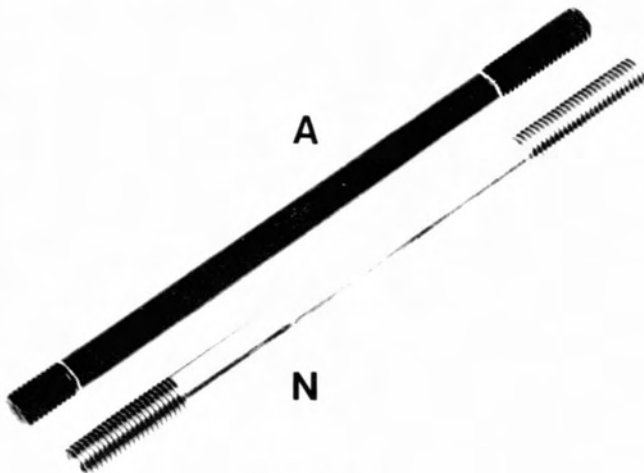
Picture 1

Cylinder head studs black-grey color short threads (A in Picture 1).

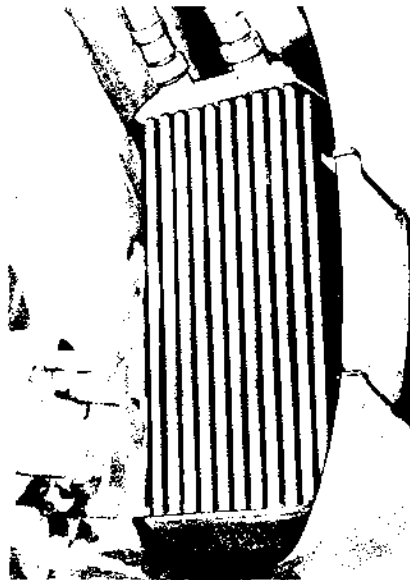
Old Tube Oil Cooler

A finned oil cooler, Part No. 930.207.053.00, is installed in the right front wheel house instead of the former tube oil cooler, Part No. 930.207.050.03, beginning with the below mentioned introduction date. In addition, the bumper has a larger opening in the area of the right fog lamp.

The old tube oil cooler is no longer available for replacements. In case of replacement, cars have to be converted for the new finned oil cooler — on 1984 models.

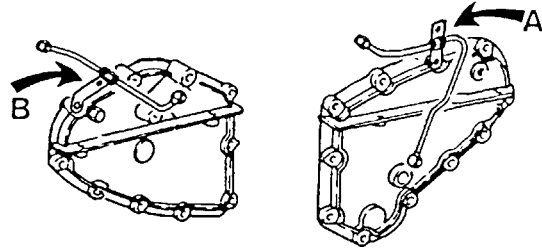
The right chain tensioner oil supply line was modified and the right and left oil supply lines are installed with an additional bracket on the chain housing cover. (Arrows in picture).

New style parts should be installed when performing engine or oil leak repairs in the area of oil supply lines.

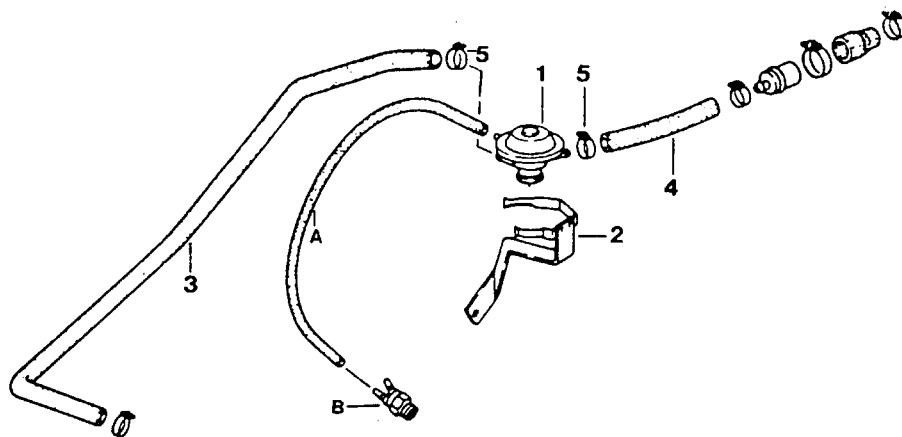
Figure II

Incorrect vacuum hose connection on temperature switch (B in Figure II) can cause rattling noise. Angled connection of temperature switch connects to vacuum source and straight connection to air valve.

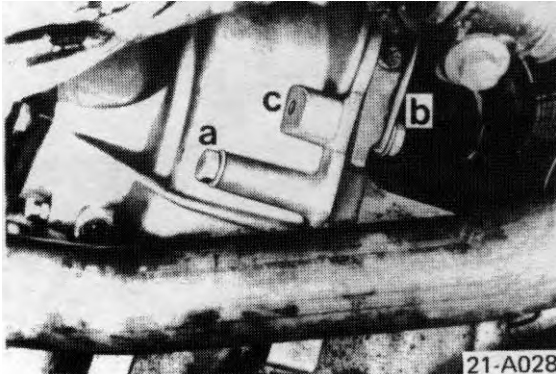
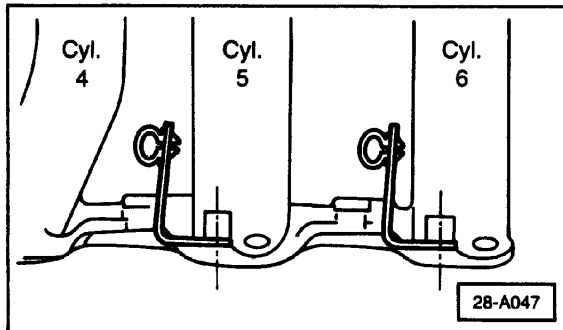
Surging or stalling at idle may be caused by spark plug cable induced voltage to the DME/injection valve harness.

Brackets and securing clips for spark plug cables on cylinders no. 4 and 5 have been introduced in production to maintain sufficient clearance. This prevents possible current induction.

These additional brackets and clips have been installed in production as of:

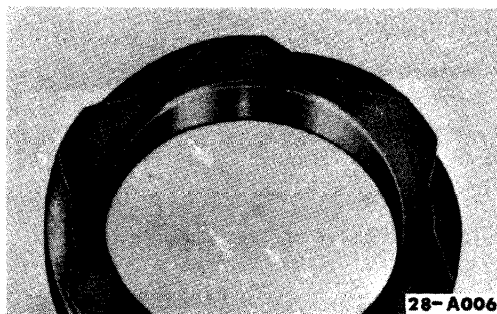
NEW
(930 102 115 01)

New drive gear is identified by "T" on face and is light yellow. Old gear is no longer available as spare part

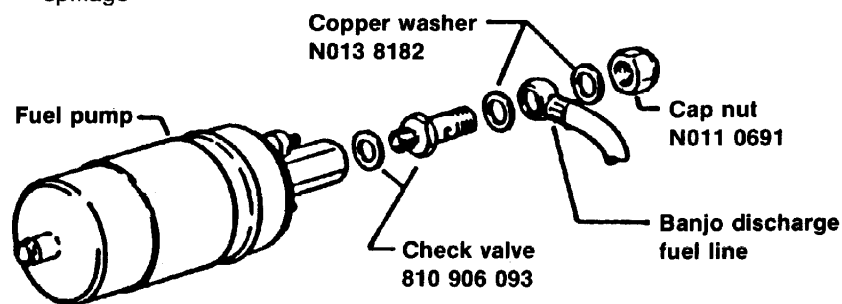
20-A073

Replacement check valves are now available for late model CIS vehicles, eliminating requirements that entire fuel pump be replaced if check valve malfunctions

- remove existing discharge hose fitting together with copper washers
- install new check valve using new washers as illustrated
- torque check valve and cap nut to 20 Nm (14 ft lbs)

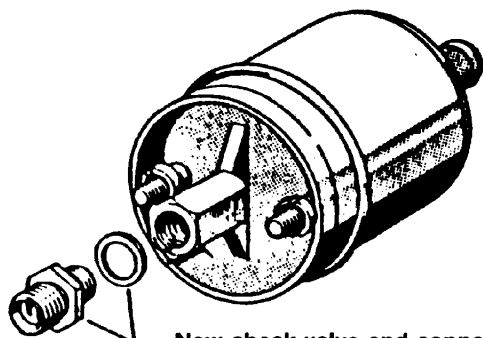
20-A074

New check valve and copper washer;
Part No. 911 608 951 00

- remove original fuel line adapter from pump and install new check valve as illustrated
- torque check valve to 20 Nm (14 ft lbs)
- connect discharge hose to new check valve and torque to 20 Nm (14 ft lbs)
- remove clamping device from suction hose
- start engine and check for leaks

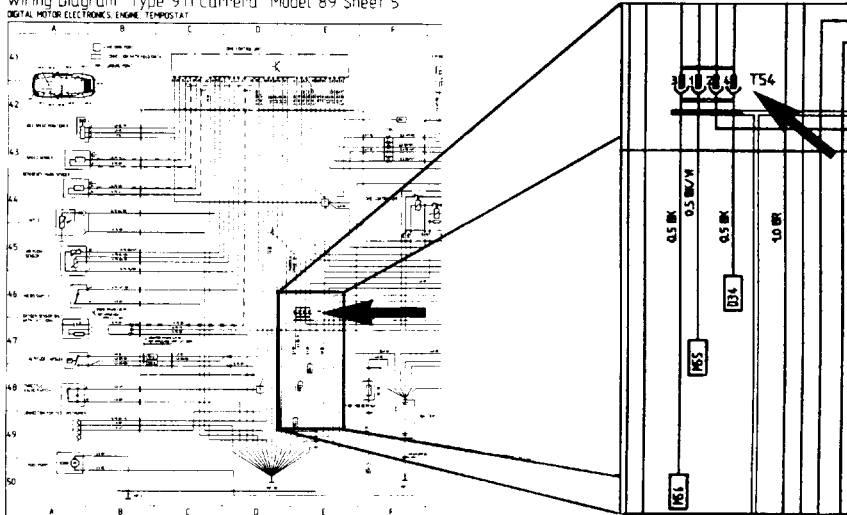
Wiring Diagram Type 911 Carrera Model 89 Sheet 5

Concern: Repair Manual Wiring Diagrams, Model 1988, Sheet 5, Field E46
 Repair Manual Wiring Diagrams, Model 1989, Sheet 5, Field E46
 Wiring Diagram Book 1988 PNA 000 061, Sheet 6, Field E46
 Wiring Diagram Book 1989 PNA 000 066, Sheet 5, Field E46

Correction: Terminal 1, female connector, should connect to terminal 2 of male connector.
 Terminal 2, female connector, should connect to terminal 1 of male connector.
 Please update your wiring diagrams.

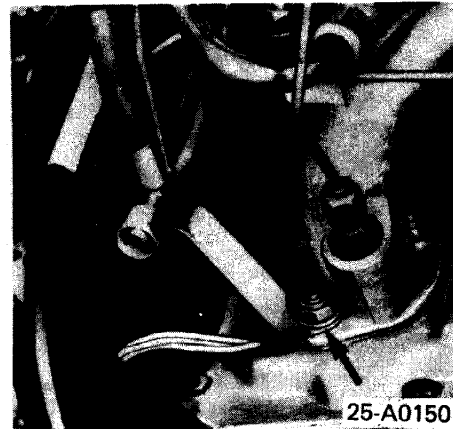
25-A0150

Particularly important on the Type 911 SC is the ground connection on the intake manifold at left rear (arrow)

- insert wire connector into terminal marked II as shown

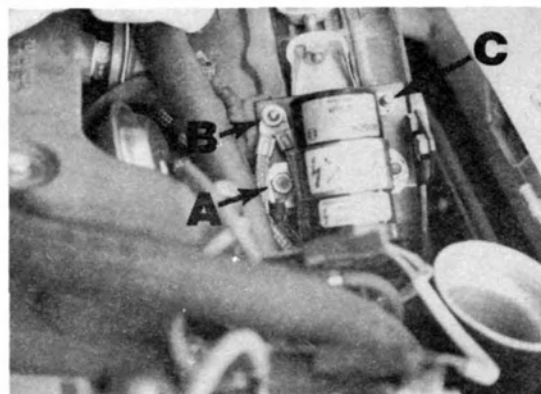
Figure 1

Loose or poor ground connections may cause intermittent loss of power or poor engine performance. To check for this condition, inspect MP XII (location A in Figure 1) and correct as follows:

1. Remove intercooler.
2. Remove M8 nuts from locations A, B, and C.
3. Lift coil bracket and use sandpaper to remove the paint from bracket in the area of stud hole C top and bottom and stud hole B topside.
4. Clean ground wire terminal and check terminal crimping.
5. Apply light coat of battery pole grease on all cleaned bracket surfaces.
6. Reinstall coil bracket. Relocate ground wire A onto location B and torque M8 nuts to 20 Nm (14 ft. lbs.).
7. Reinstall intercooler using new O-ring seals.

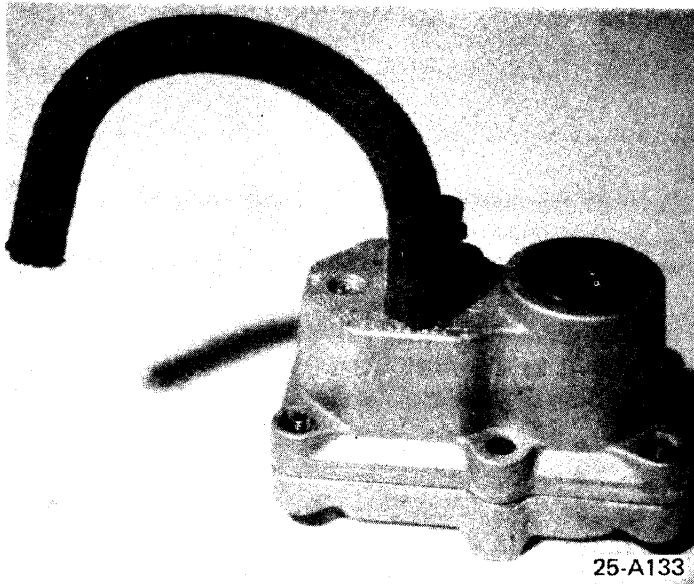
25-A133

A new-type control-pressure regulator is used on 1980 cars. It is the only type now available as spare part. Old regulator is no longer available. New regulator has vacuum-hose connection on top (arrow) to vent moisture

- install 150-mm long hose (Part No. 999 181 709 50) on vacuum connection of new regulator and point open end of hose down as shown

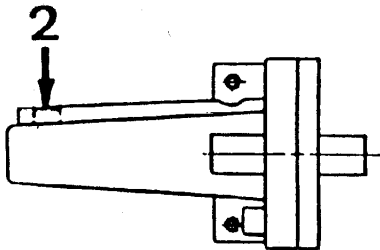
25-A171

Should the engine idle remain abnormally high after the warm up period with the new version regulator, the following modification should be performed:

- remove auxiliary air regulator
- carefully drive in end cap (arrow 2) exactly 0.5 mm. The distance of 0.5 mm must not be exceeded.
- reinstall auxiliary air regulator.

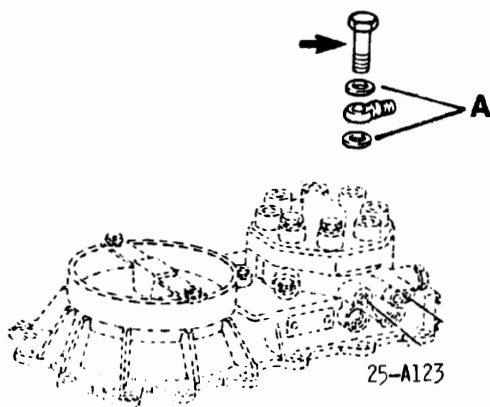
Engine misfiring may result from fuel restriction to one or more injectors

- check for loose fuel filter screens in fuel outlet ports of fuel distributor
- if loose, replace all 8 bolts (arrow) with new bolts, Part # 930 110 547 00

- clean filter screen in fuel feedline adaptor
- run engine and check performance

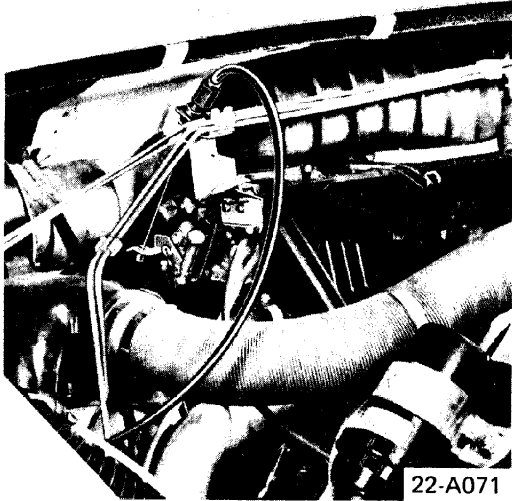
Previous version

Cruise-control cable bracket has been modified in production (beginning May, 1981).

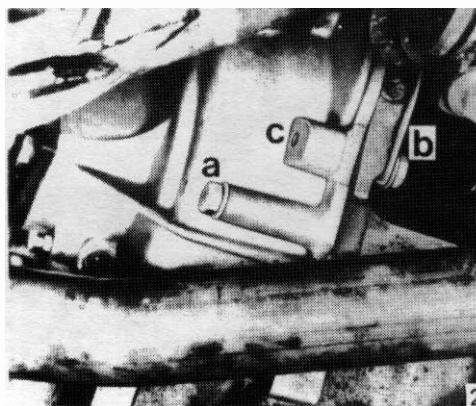
Missing ground wire

Ground wire, Part No. 911 612 233 00, was not installed between engine crankcase and alternator on some early 1982 model cars. A poor ground connection can cause radio interference and a discharged battery

If above problems develop, or if alternator has to be removed for repairs, install missing ground wire as shown

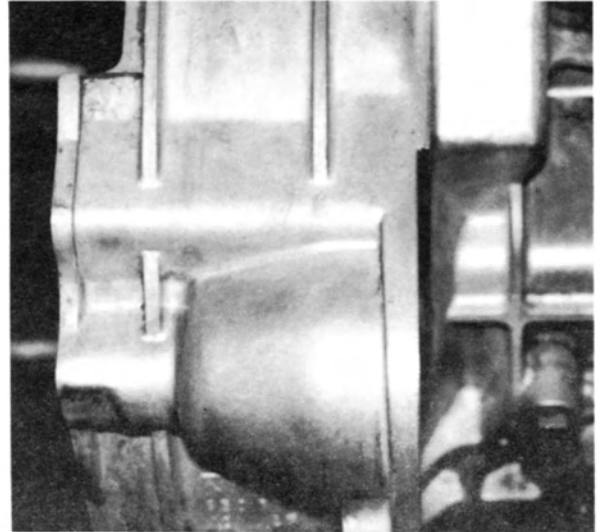
← a = 115 - 0.2 mm →

When replacing starter motors with gear damage, the starter ring gear should also be checked for damage and replaced if necessary. Transmission dimension "a" should also be checked.

If transmission housing measurement "a" is 117 - 0.2mm, starter mounting flange should be machined to dimension 115 - 0.2mm. This machining can be accomplished without disassembling the transmission.

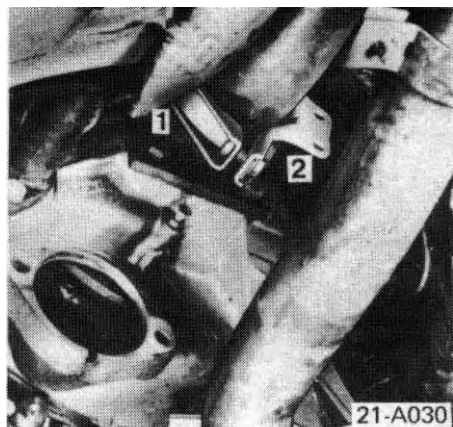
Incorrect installation of distributor drive gear will cause ignition timing to be off by approx. 13°.

During engine repairs check that distributor drive gear is correctly positioned on crankshaft.

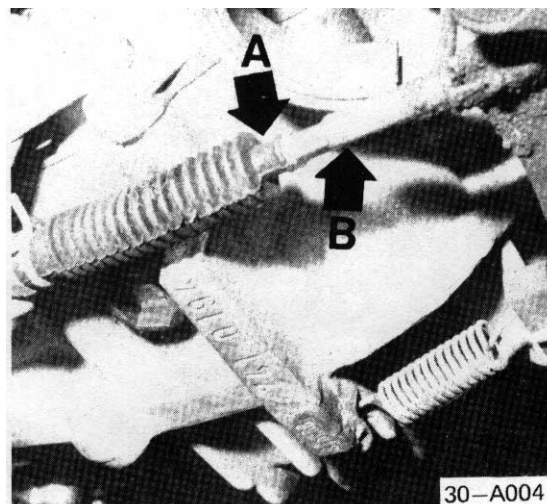
If rubber sleeve over clutch cable is installed as shown at A (not all the way to clutch release lever), the clutch cable could bind

If binding occurs, check and correct (if necessary) as follows:

- apply grease to exposed section of cable (B) toward release lever

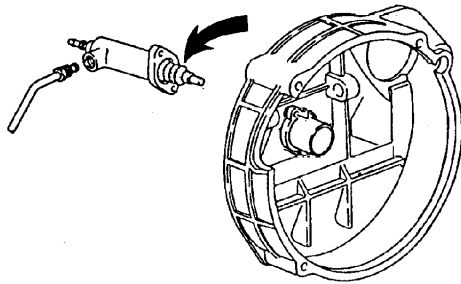
To repair clutch pedal clatter (noise that goes away when depressing clutch pedal slightly), a modified clutch slave cylinder should be installed.

The new type slave cylinder can be identified by the extended rubber boot (arrow in figure) and a spring installed inside the boot.

New slave cylinder PN 950 116 237 10

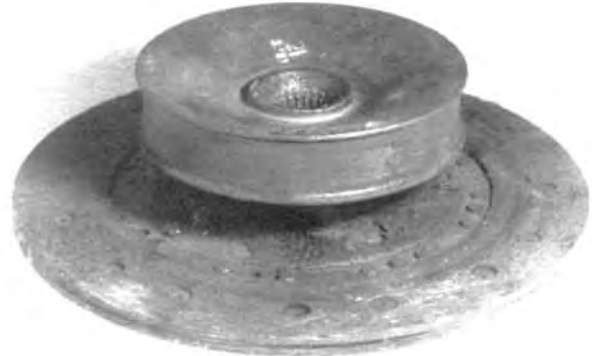
Figure 2

- Rubber hub broken loose from the metal disc plate.
- Pieces of the rubber hub are broken out.
- Rubber surface adjacent to the metal disc is cracking, shiny, and sticky.

Cause: Abuse, unless mechanical failure of throwout bearing or bearing sleeve is evident.

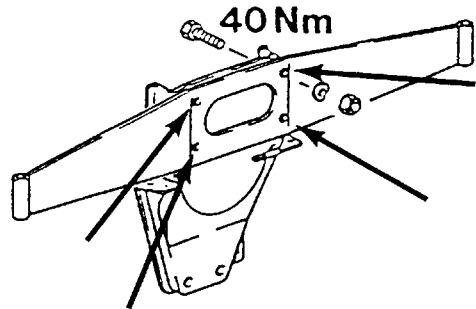
Misalignment between the transmission and engine mounts may cause stress resulting in the transfer of transmission noises to the vehicle body.

In case of transmission noise complaints, loosen all four engine carrier bolts together (see picture) and retorque to 40 Nm (29 ft. lbs.).

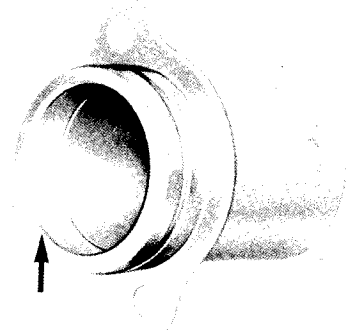
Fig. 3

- I - Old version mainshaft
- II - New version mainshaft

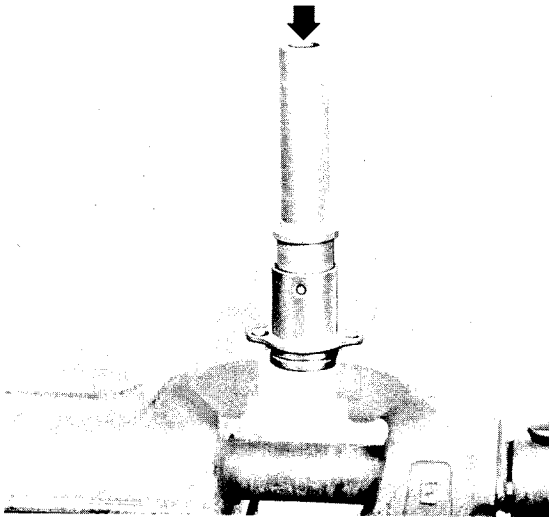
Fig. 6

Since P381a has a guide tube for the oil seal, the guide sleeve should be held in a vise during the seal installation (Fig. 6) and not on a flat surface.

The old seal installation tool P381 must be used for the old version tube (40mm) and P381a only for the new version (50mm)

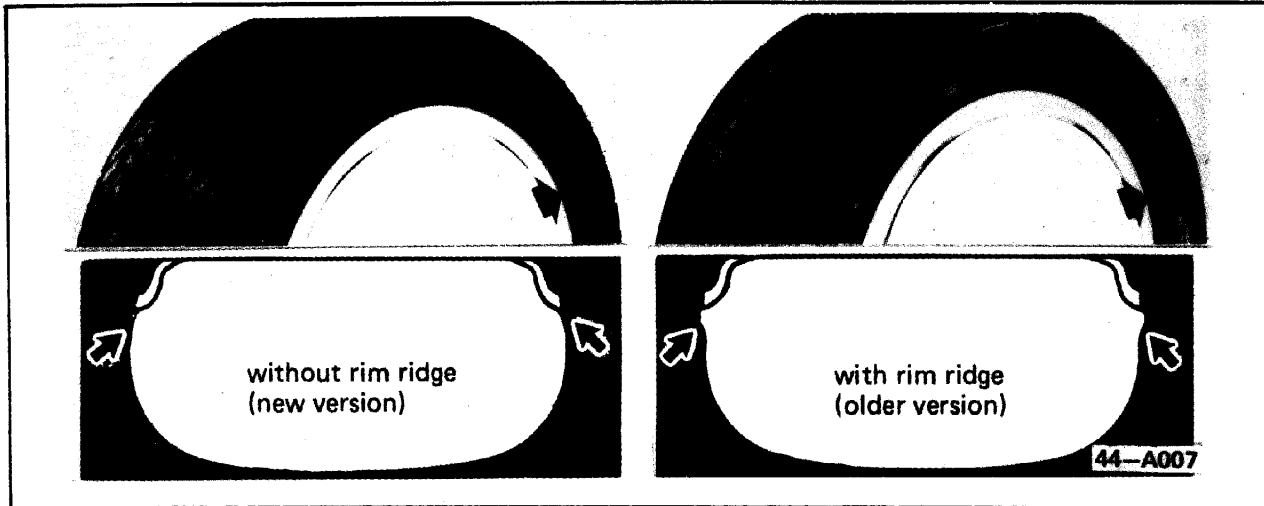
P 7 205/55 VR 16 and P 7 225/50 VR 16 tires are now available in two versions. The latest version can be recognized by the absence of a rim ridge at the inside of the sidewalls (arrow). Both tire versions will be available for replacement

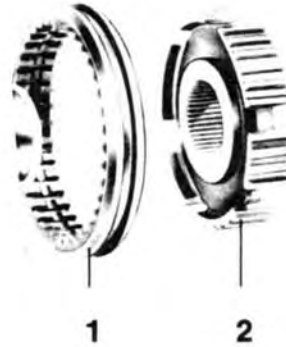
In case of complaints of jumping out of gear, always check the shift rod adjustment first.

1 - Shift Sleeve
2 - Guide Sleeve

Refer to Technical Bulletin Group 3, Number 8705, Book D, Page 140.

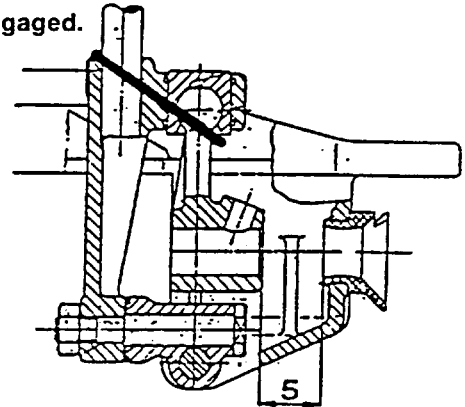
Picture 2

5mm adjusted
distance.
4th gear engaged.

1. Lift shift diagram cap off shift lever knob.
2. Unscrew shift lever knob allen screw and pull off knob.
3. Dismantle center console, slide over shift lever and put aside (electrical equipment remains connected).
4. Measure distance between shift base bushing and shift lever with 4th gear engaged. Should be 5mm (picture 2). If necessary, loosen shift base bolts and move shift base to obtain correct adjustment. Torque bolts to 23 Nm (17 ft. lbs.).
5. Reinstall center console and shift knob.

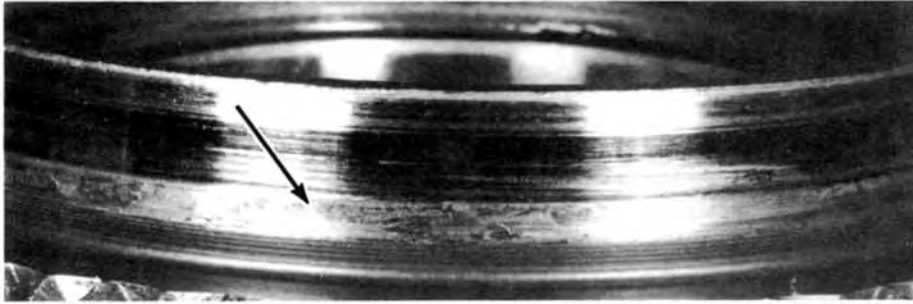
Metal transfer from synchronizing ring

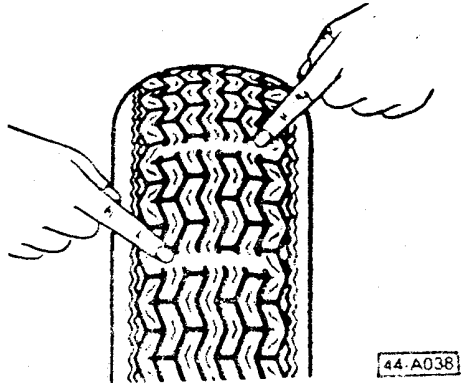
Tread wear indicators

The ridge has a height of 1.6 mm. When tread wear reaches this point, the ridges become visible. The appearance of the wear indicators signals the need for tire replacement.

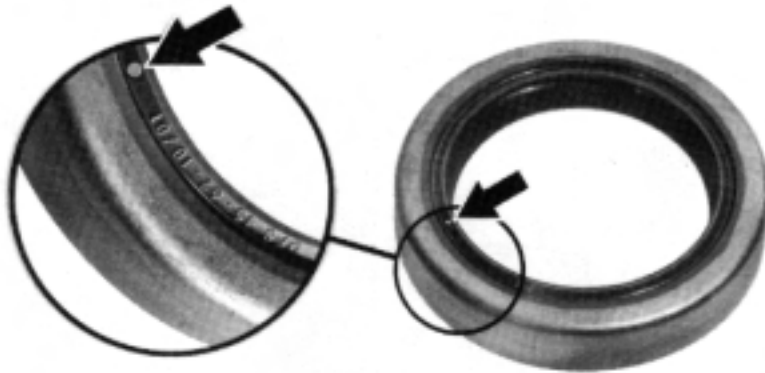
When repairing cars with squeaking or whistling noise from the front wheel seals (prior to the above production date) install new type seals which can be identified by a molded rubber dot next to the lettering (arrows in figure).

The space between the sealing lips of the sealing ring should be filled with wheel bearing grease prior to installation. Seals without the marking (rubber dot) may be used up on 924, 944 and 928 Series cars.

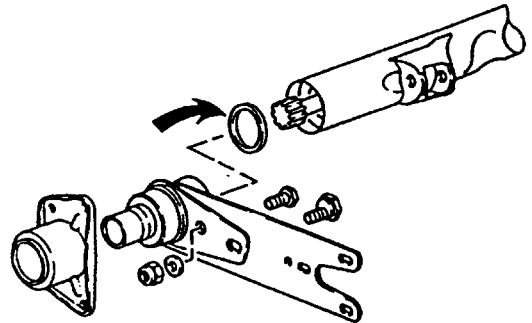
A plastic spacer (2mm) is installed on some vehicles between the rear axle cross tube and the spring plate to compensate for body tolerances. This prevents contact between the spring plate mounting bolts and the vehicle body.

This spacer is usually installed on one side only. During repairs the spacer has to be reinstalled.

Spacer Part Number: 911 331 106 00

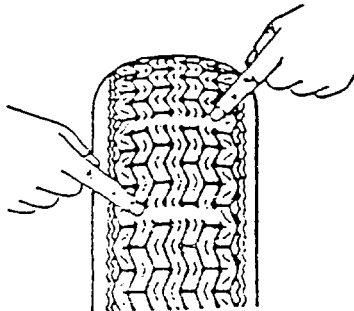
Tread wear indicators

The ridge has a height of 1.6 mm. When tread wear reaches this point, the ridges become visible. The appearance of the wear indicators signals the need for tire replacement.

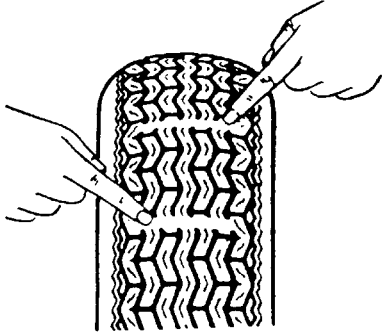
Supporting Webs

Winter tire treads will usually have supporting webs in the tread base which could stop drainage when the treads are worn to a height of approximately 4mm. It is then necessary to drive especially careful on wet roads.

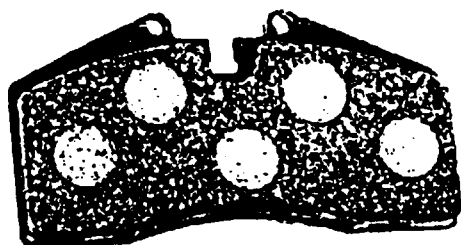
Figure 3

Early 1988 Turbo S vehicles have asbestos-free brake pads with sintered metal plugs (Part Number 928 351 939 03) installed on the front axle up to VIN 95JN151487 (Fig. 3). Existing stock of pads may be used up. **Vibration dampers cannot be installed with these pads.** Pads with and without plugs must not be mixed on a vehicle.

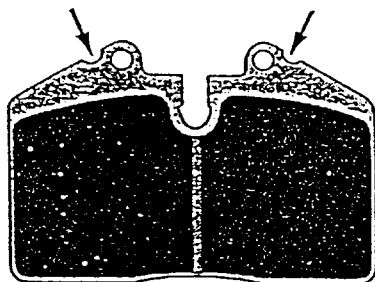
Figure 1

Color coding and semicircular cutouts, (Fig. 1) in the area of the retaining pin holes identify asbestos-free brake pads.

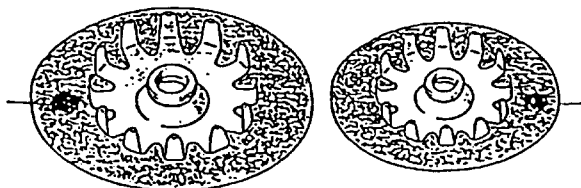
Figure 2

Vibration dampers (Fig. 2), must be installed on cars from model year 1986 (four piston calipers) on the front calipers between the pistons and the brake pads. Brake pad thickness has been reduced from 18.2 to 17.5mm. When replacing brake pads, the vibration dampers must be replaced also.

Note: Some early 1989 production cars received one-piece vibration dampers. In case of noisy brakes, two-piece vibration dampers should be installed.

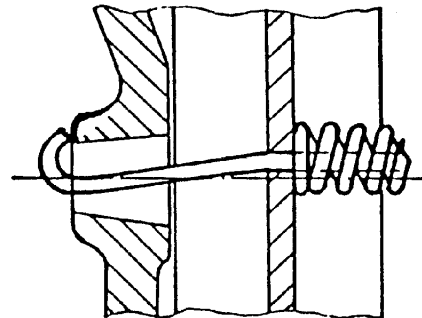
**Incorrect
Figure 2**

Incorrect installation (Figure 2) will result in breakage of the retaining spring and possible damage to the brake shoes and related components, which is not a warranty matter.

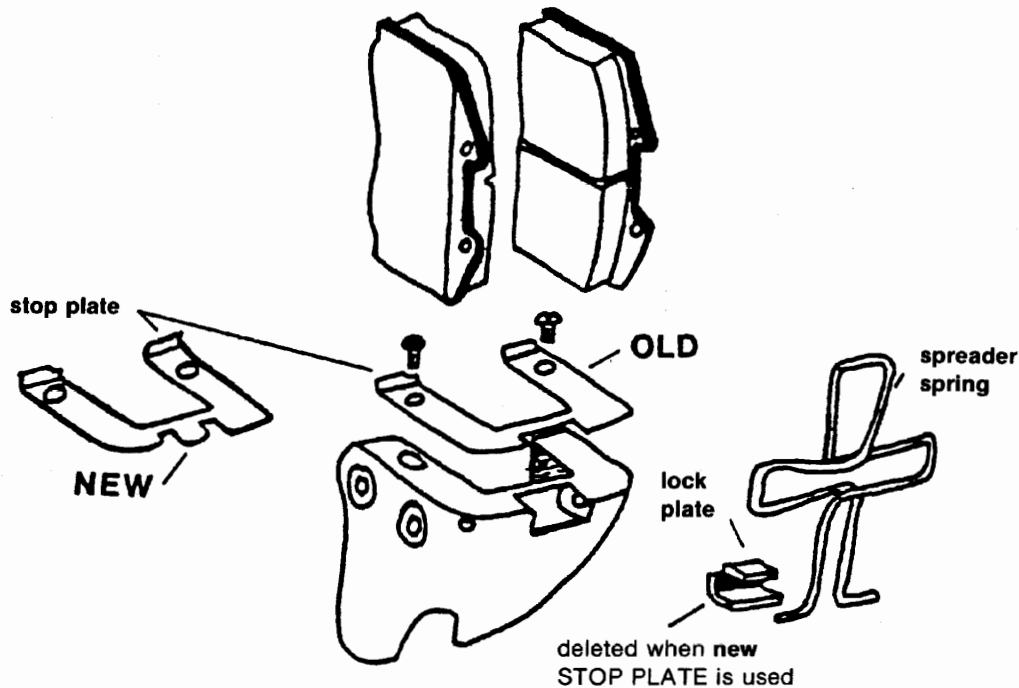
Stop plate for brake pads has been changed.
Spreader springs now lock into position without
use of separate lock plate

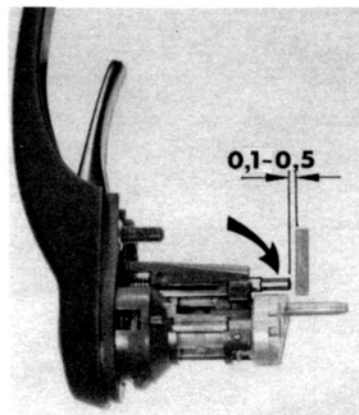
1. Threaded control rod on door handle is adjustable (3mm Hex, arrow).
2. A self-made tool from 2mm thick sheet metal or a spare key without head can be used to turn the control rod to make the adjustment. (See sketches)
3. With door trim panel removed and window glass closed, adjustment can be observed through window glass opening.

Distance between control rod and lock lever should be adjusted to 0.1-0.5mm (See picture).

New type outer door handle and lock can be installed in older cars separately. However, to improve lock operating effort, both handle and lock should be replaced.

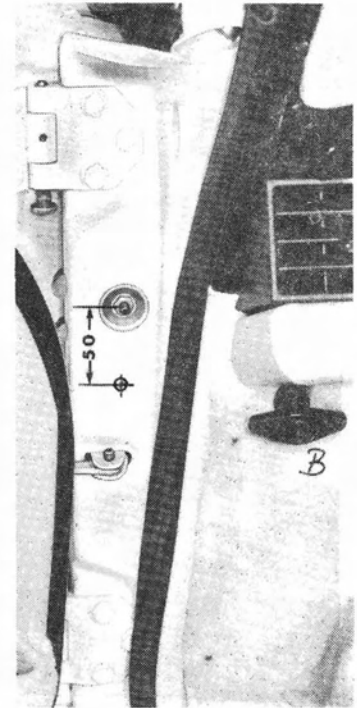
Figure 1

This requires drilling a new hole, 8.4 mm diameter, 50 mm below the old door contact switch hole (Figure 1). Deburr edges of the new hole and treat edges with rust preventing paint. Relocate switch into new hole. Install plug PN 911 531 999 00 in old hole.

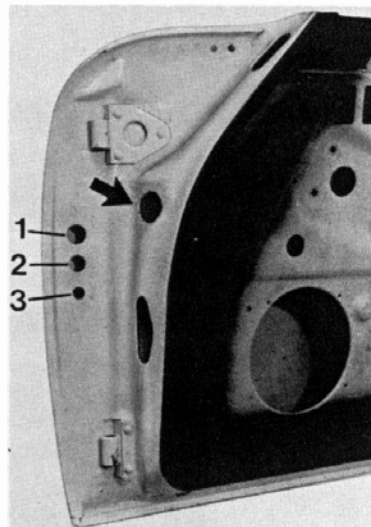
Figure 1

The hole (arrow in Figure 1) must be closed with grommet Part Number 999 703 066 50.

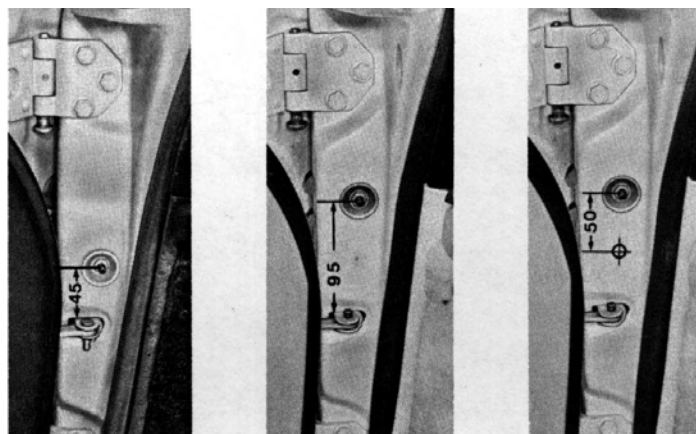
**Figure 2
Hinge Pillars**

This requires drilling a new hole, 8.4mm in diameter, 50mm below the old door contact switch hole (Figure 2). Deburr edges of the new hole and treat edges with rust prevention paint. Relocate switch into new hole. Install plug Part Number 911 531 999 00 in old hole.

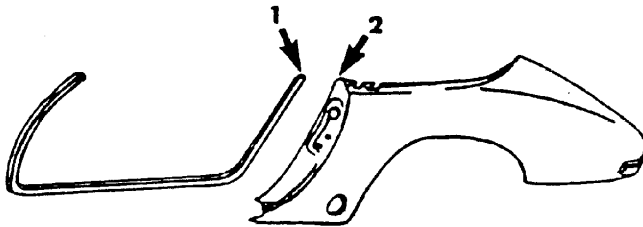
The door seal has been changed from a lip-profile to a hose-profile configuration.

The end of the seal in the B-pillar area (arrow 1) is closed with a mushroom-shaped cover. This cover has a piece which is glued to the B-pillar (arrow 2).

Water leaks in this area on previously produced vehicles may be corrected by installation of the mushroom-shaped cover on the seal

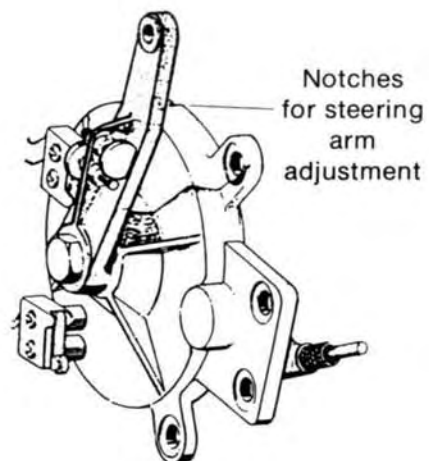
Picture 3

3. If the adjustment of the centering lugs is not okay, first check the synchronization of the left and right swivel gear levers. With the top closed, the marks on the gear housing and on the lever should line up. (Picture 3)

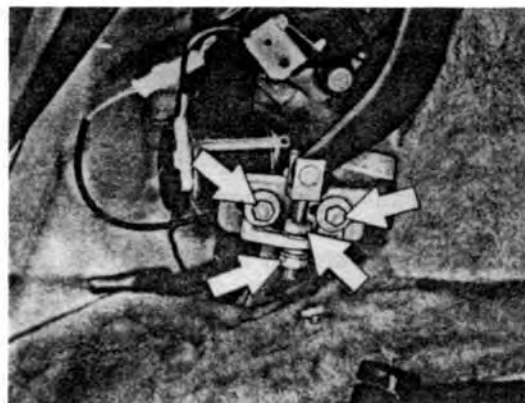
Picture 4

- A. Adjustments are made on the bearing brackets (Picture 4).

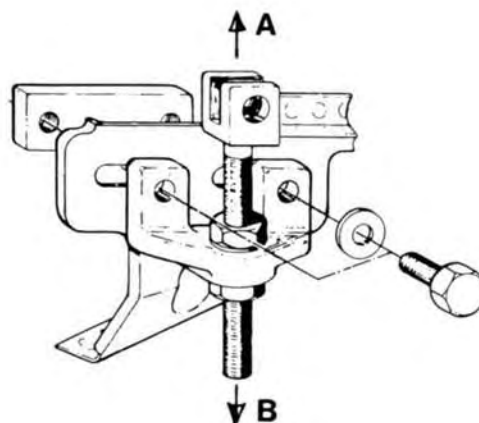
Picture 5

The bearing bracket slotted holes should be centrally located for basic adjustment. Adjustment of the threaded fork upwards (A in picture 5) adjusts the top forward (in driving direction).

Adjustment of the threaded fork downwards (B in picture 5) adjusts the top rearward (against driving direction).

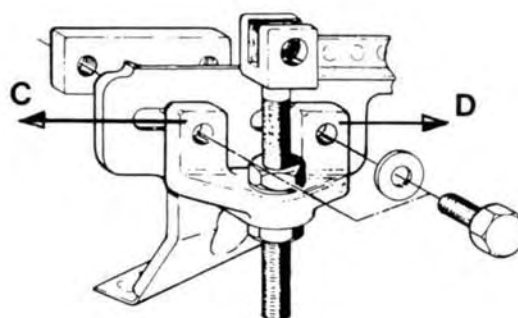
Picture 6

- B. Displacement of the bearing bracket from center position in the slotted holes forward (C in picture 6) produces slight adjustment in driving direction. Displacement of the bearing bracket rearward (D in picture 6) produces slight adjustment against driving direction.

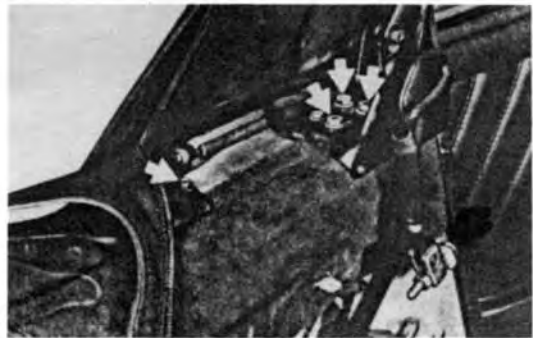
**B - Pillar
Picture 7**

5. Should the adjustment of the threaded forks and bearing brackets not be sufficient, the entire top can be moved forward or backward by loosening the rear bow hinge and rear window bracket screws (14 screws, arrows in pictures 7 and 8).

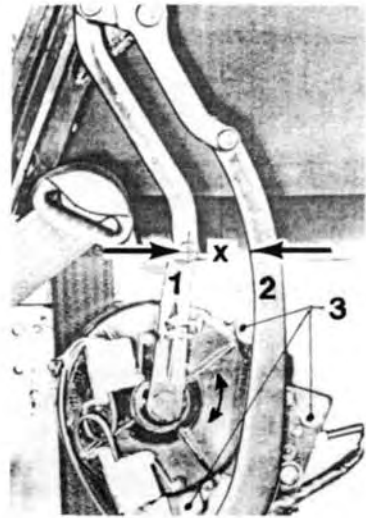
Picture 9

To do this close the top and loosen the swivel gear mounting bolts (3 in picture 9). Pull the levers together by hand (direction of arrows in picture 9). Tighten swivel gear mounting bolts in this position. Check distance (X in picture 9) between the point of attachment of swivel gear lever/thrust rod (1 in picture 9) and frame arm (2 in picture 9). Maximum difference between left and right side: 5mm.

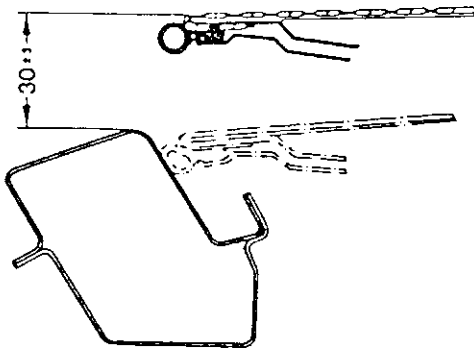
Figure 1

The micro switches are adjusted correctly if both switches switch at $30 \pm 3\text{mm}$ distance "upper roof edge to upper windshield frame edge" (Figure 1).

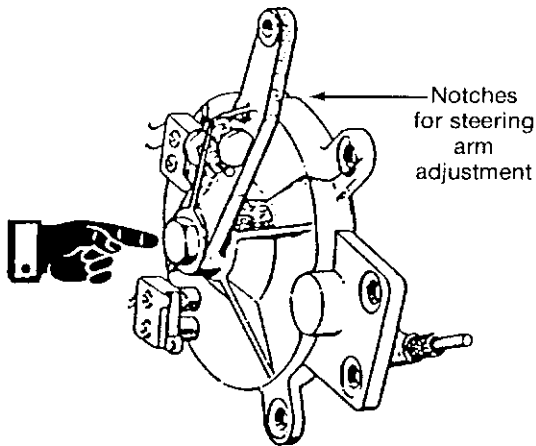
Figure 1

When repairing Cabriolet tops with noisy transmissions, first check synchronization of the left and right swivel gears. Make the necessary adjustments and recheck for noise before replacing parts.

Torque value for steering arm bolt (Fig. 1):
35 Nm (25.5 ft. lb.)

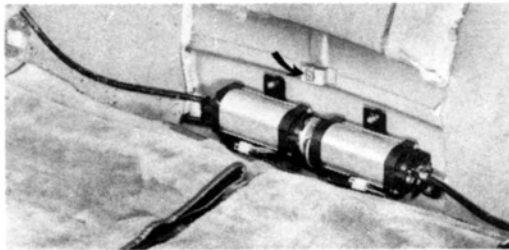
An excessively long mounting screw for the rear wall trim panel (arrow in picture) could cause scratches in the middle of the rear window.

To correct this condition, install a shorter screw, 3.5 x 16 mm.

Part Number: 900 145 038 07

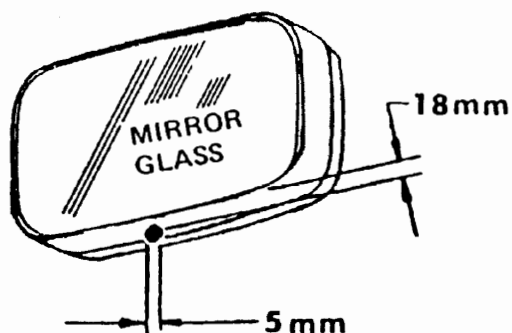
Outside mirror housing now has water drain hole at bottom to prevent clouding of mirror glass.

To prevent possible mirror clouding on earlier production cars, proceed as follows:

— drill 5 mm (11/64 in.) dia. drain hole centered left to right through bottom of mirror housing 18 mm (11/16 in.) in front of housing

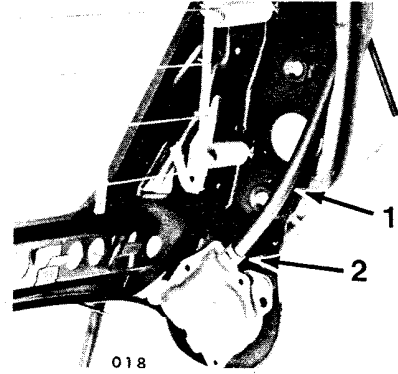
In case of improper operation of the electric backrest adjusting mechanism or excessive backrest flex, the seat back gearbox cables may have become disconnected at the gearbox. To repair this situation, the following procedure should be applied:

1. Remove seat and take off backrest.
2. Loosen backrest trim panel partially.
3. Shorten flexible shaft housing (Arrow 1) on gearbox end by 5 mm.
4. Secure housing to gearbox with suitable hose clamp. (Arrow 2)

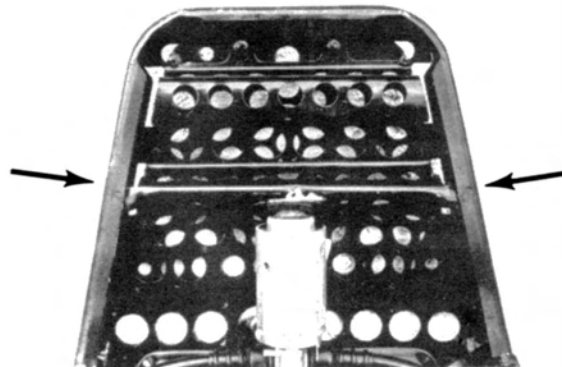
Seat back frame supports may be repaired in the areas indicated by arrows utilizing MIG welding.

Use care when welding to avoid excessive heat build up in seat back frame assembly.

Welding in other areas of the seat back frame or seat bottom frame is not allowed.

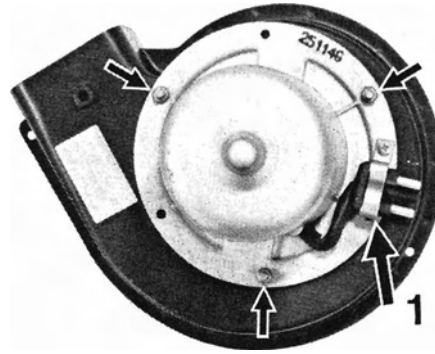
Figure 1 (new version shown)

Concern: Replacement rear heater fan modified.

Repair Information: The replacement rear heater fan (new Part Number 965 624 151 00) has a repositioned wiring plug. When installing this new version heater fan in the 911 Carrera, model years 1984 (E) through 1989 (K), the fan motor must be repositioned in the fan housing.

Work Procedure: Remove the three fan motor mounting nuts (arrows in Figure 1). Reposition the motor 120° clockwise in the housing. Reinstall nuts and torque to 2.5 Nm (1.85 ft. lbs.).

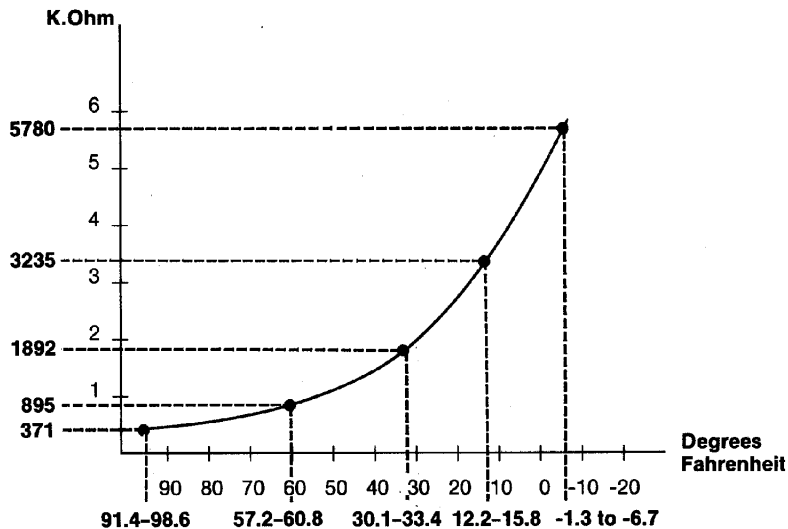
The temperature sensor is installed on the left fog light mounting.

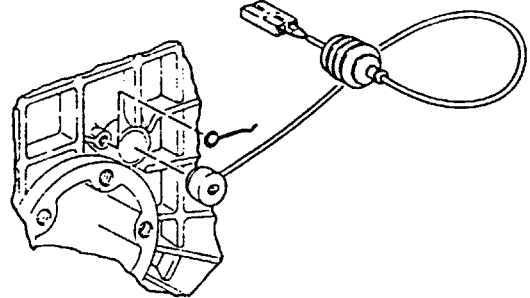
An inoperative speedometer or no speed reading up to approximately 30 mph could be caused by a malfunctioning pulse sender.

The pulse sender must be installed in the differential cover clean and absolutely straight in the cover, otherwise an incorrect speedometer display could result.

When replacing pulse sender, both sender and spring lock should be replaced.

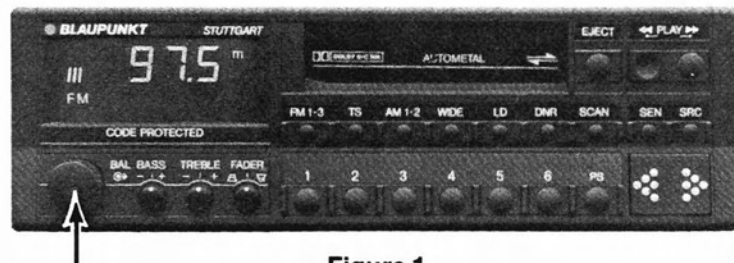
Figure 1

Concern: Replacement of broken radio knobs.

Replacement volume control knobs for Stuttgart radios (arrow Figure 1) are available as spare parts.
Part Number PNA 645 014.

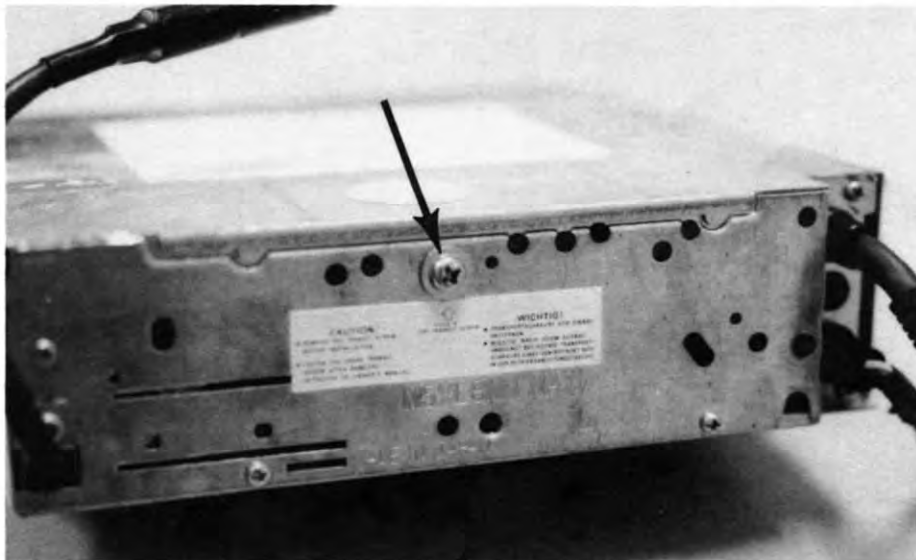
Porsche/Alpine Compact Disc (CD) players have a transport locking screw (arrow) installed at the Alpine factory. This screw prevents damage to the disc transport mechanism during shipment.

When installing a new Porsche/Alpine CD player, the transport screw must be removed and placed in the glove compartment with the owner's manual. Failure to remove the transport screw before final installation of the CD player into the vehicle will cause skipping of the disc tracking mechanism.

When the CD player is installed into the vehicle at the Porsche factory, this screw is removed and placed in the glove compartment with the owner's manual. Should the Porsche/Alpine CD player need repair, the transport screw **MUST** be reinstalled before shipping the unit.

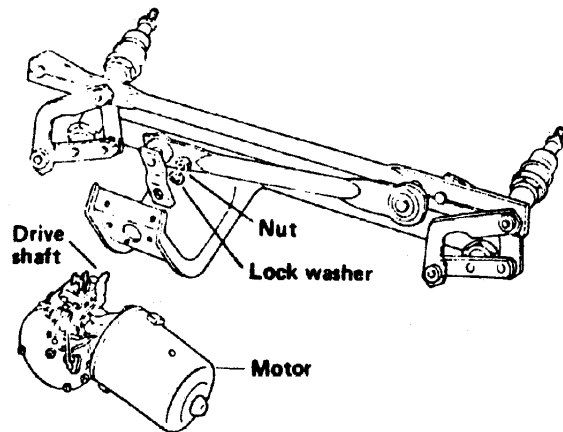
92-A030

The self-locking nut at windshield wiper motor drive-shaft has been replaced with hex nut and lock washer, as shown

In case of repairs, use new parts:

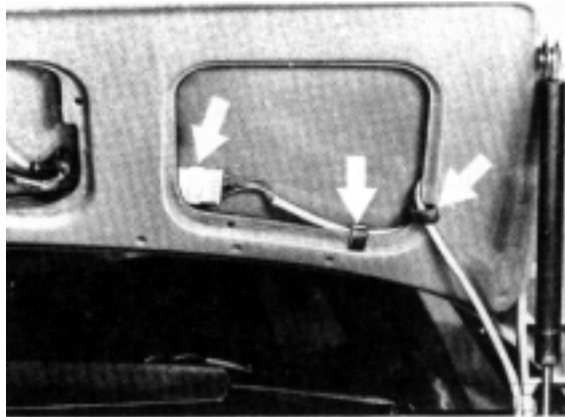
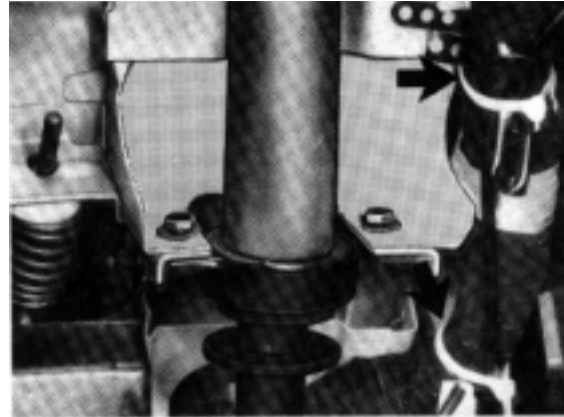
When working on a vehicle, it is often necessary to move and/or disconnect a wiring harness to facilitate repairs. When reinstalling such a harness, it is absolutely necessary to properly route and fasten it. The routing and installation of wiring harnesses in Porsche vehicles is carefully designed to prevent any contact with other parts of the vehicle that have the potential to damage the harness; therefore, the reinstallation must duplicate the original installation. All wire ties and harness clips should be attached in their original location. All electrical plugs and connectors should be checked to ensure proper engagement. Any insulation pads, bushings, grommets, shields and/or covers removed during repairs must be reinstalled in their original location and in a manner that will not damage the harness or related components.

Failure to properly route and secure a wiring harness after repair can result in unwanted squeaks, rattles or damage to the harness and other parts of the vehicle electrical system. Damage to the harness, if undetected, may result in short circuits and under some circumstances may result in an electrical fire.
