Technical Bulletin

Model 911SC, 928S	Group 00
Part Identifier N/A	Number 83-01

Subject: Location of VIN Label

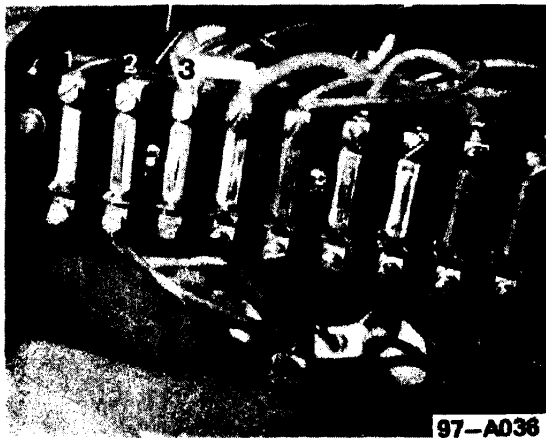
If air conditioner fails to operate or if heater fan does not come on, loose connection at respective fuse panel may be the cause

- check auxiliary fuse panel (in luggage compartment) for loose connection at terminal #2

- bridge terminals #2 and #3 (arrow) with jumper, Part # 901 612 835 01, or use jumper wire (at least 12 AWG)

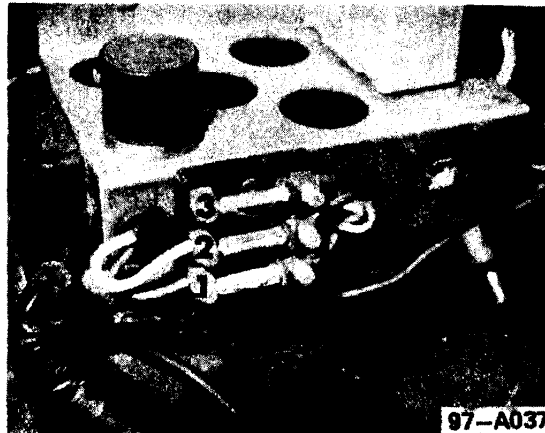
Heater fan not working

- check auxiliary fuse panel (in engine compartment) for loose connection at terminal #2

If connection is loose, move red wire from fuse terminal #2 to terminal #3

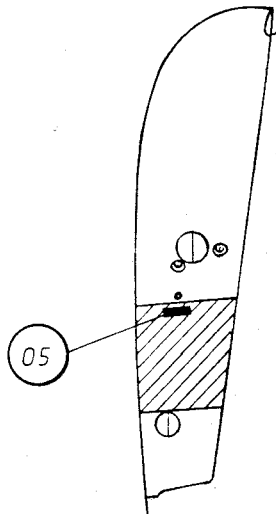
05 Door, left and right
Door inside under the lock

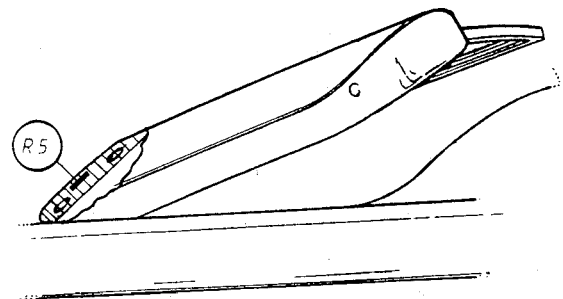
R5 Door, left and right
Door inside between hinges

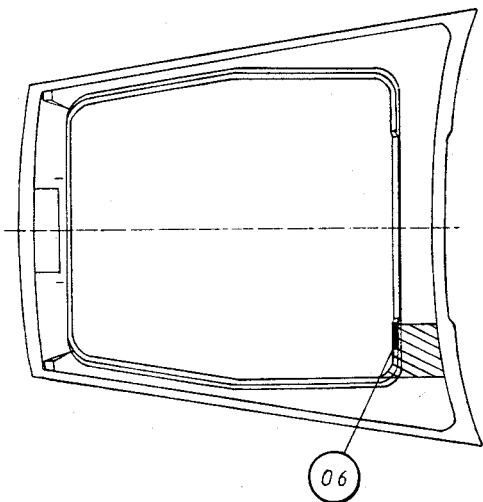
Location of Markings 911 and 911 Turbo
Original Part "O"
06 Front hood
Hood frame rear right

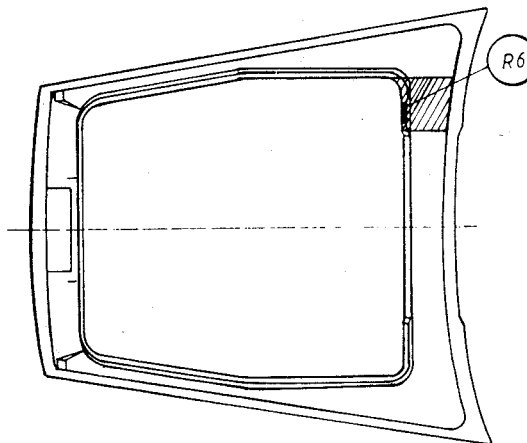
Replacement Part "R"
06 Front hood
Hood frame rear left

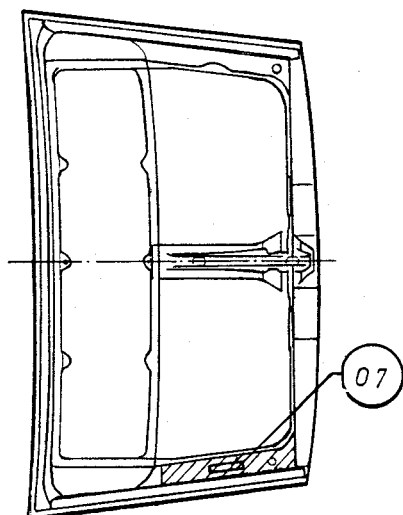
07 Engine lid
Lid frame rear right

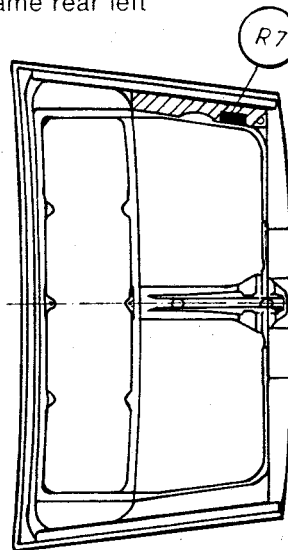
07 Engine lid
Lid frame rear left

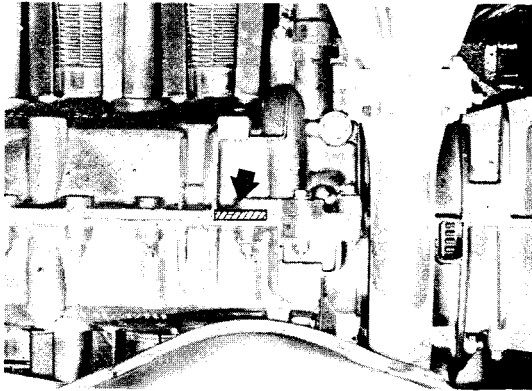
Location of Markings 911 and 911 Turbo
Engine Original
Bottom of engine

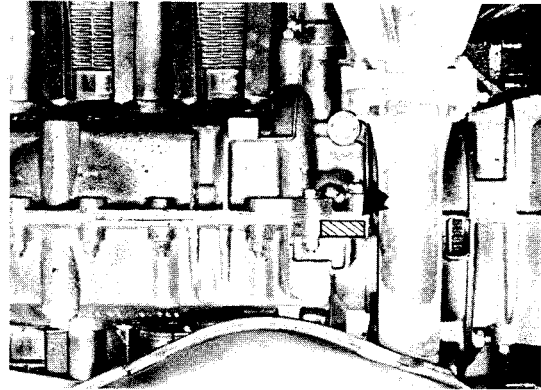
Engine Replacement
Bottom of engine

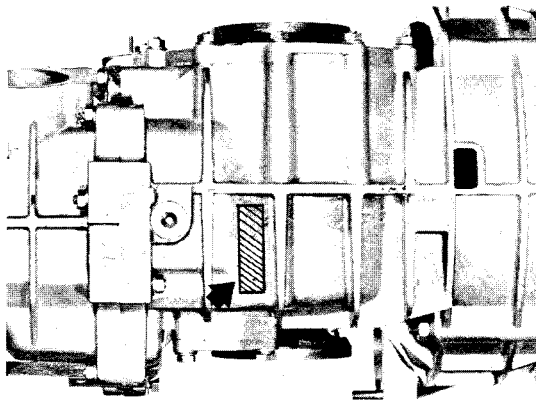
Transmission Original
Bottom of Transmission

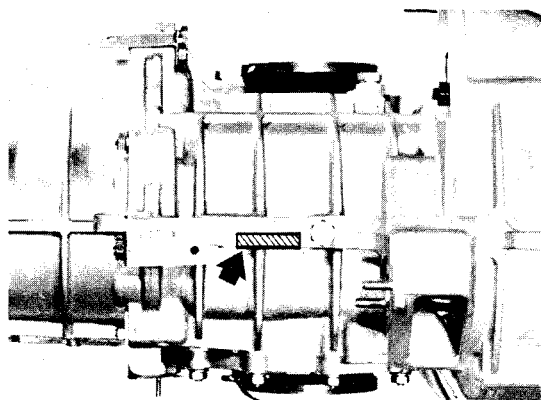
Transmission Replacement
Top of transmission

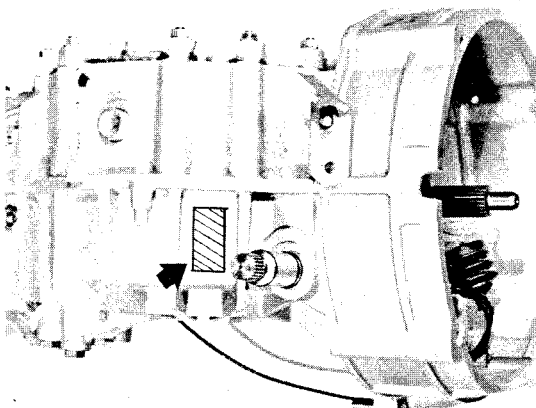
911 Turbo
Bottom of transmission

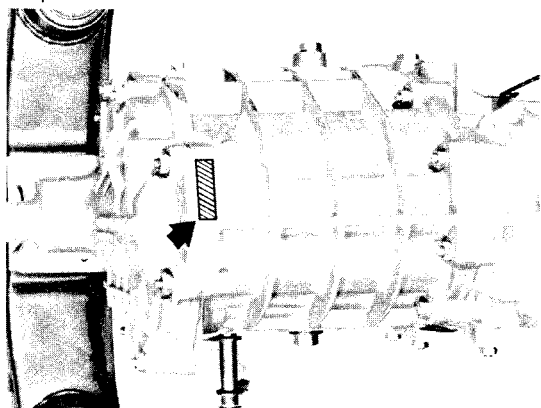
911 Turbo
Top of transmission
